**LAKE SCIOTO DAM
PHELPS COUNTY, MISSOURI
MO 30097**

**PHASE 1 INSPECTION REPORT
⑥ NATIONAL DAM SAFETY PROGRAM**

LAKE SCIOTO DAM
PHELPS COUNTY, MISSOURI
MISSOURI INVENTORY NO. 30097

Name of Dam:	Lake Scioto Dam
State Located:	Missouri
County Located:	Phelps
Stream:	Unnamed Tributary of Luther Branch Creek
Date of Inspection:	May 21, 1980

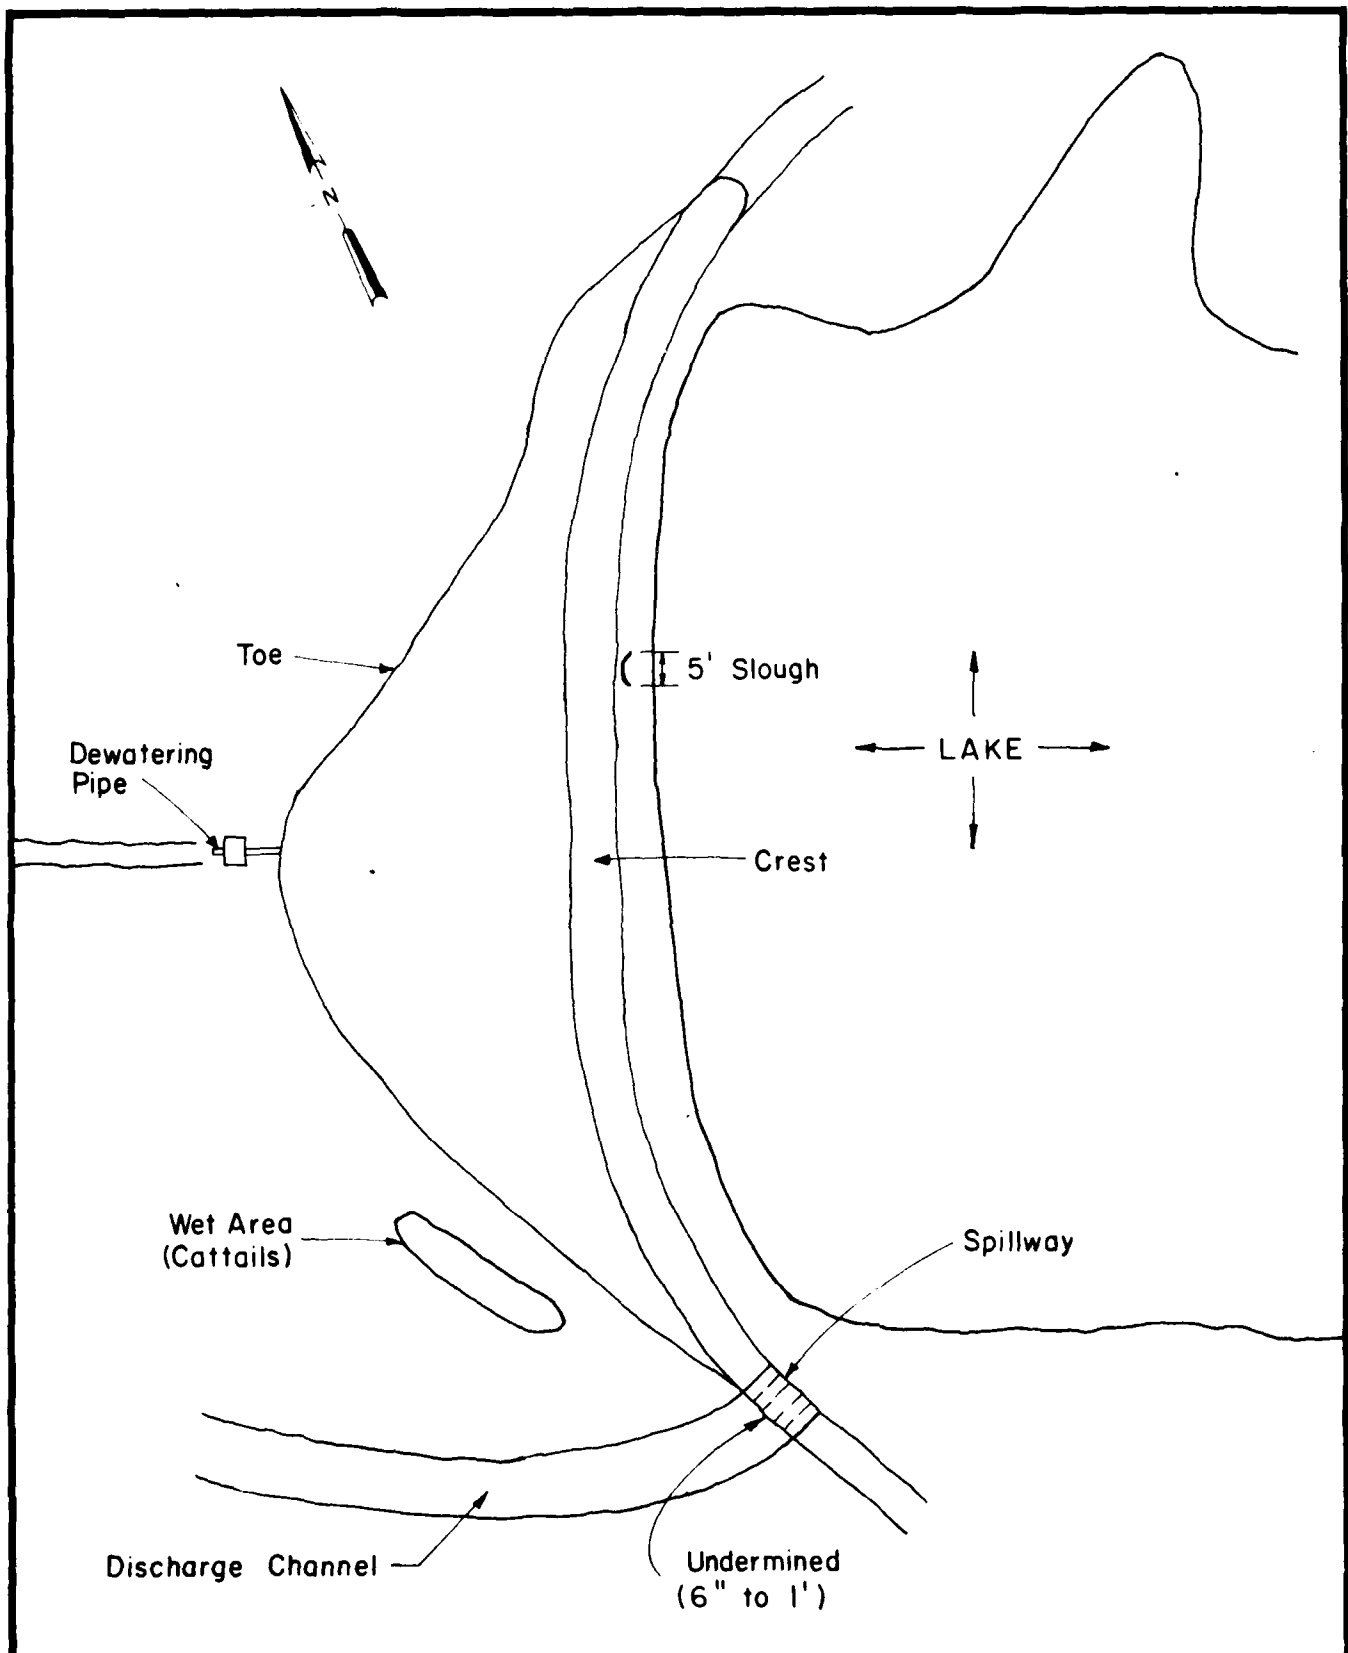
PLAN SKETCH OF FEATURES

The dam embankment appears to be in good condition. There is no wave protection for the upstream embankment face, and some sloughing and minor erosion was noted. The embankment crest is clear and fairly level. A gravel road passes along the crest. The dam was constructed slightly concave downstream (see Photos 2 and 3). The downstream embankment face is clear except for some widely scattered small tree and brush growth. A seepage area was observed at the left abutment-dam contact (see Sheet 4, Appendix A). Although no seepage flows were noted, the area was wet and soft, with cattail growth (see Photo 8). Sheet 5 of Appendix A presents a plan sketch of the dam showing observed features.
